Electrical Transformer Fire and Explosion Protection

By Jackson Bishop; Alonzo Rodriguez, P.E.;

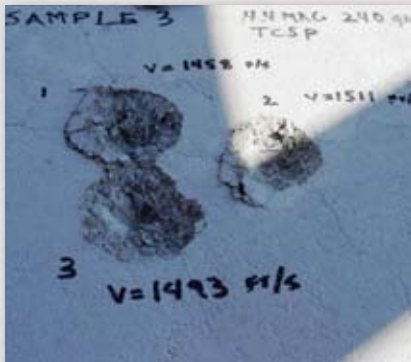
Refractory Concrete Ballistics Test

A projectile blast barrier having sufficient impact resistance to survive shrapnel impingement is also essential to protecting nearby assets. Fire caused by transformer failure may initiate an explosion, blasting projectiles such as steel fragments and porcelain up to 250' or more into the surrounding areas. Such projectiles have been found embedded into transformers, equipment and office walls in nearby buildings. As there is yet no standards for firewall impact loading, experts in the fields of ballistics and explosives have recommended applying UL Standard 752. This is equivalent to a firewall panel stopping a 44 Magnum projectile with no through-penetration or spalling.

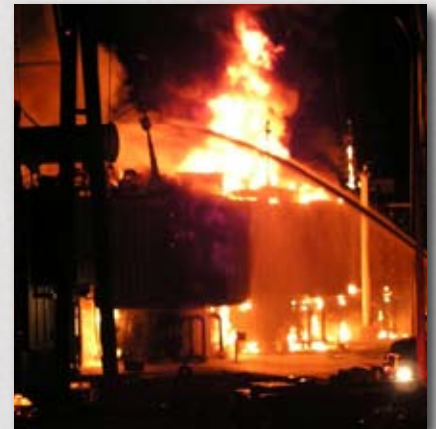
Primary Transformer Fire Ignites Secondary Transformer

When a transformer does fail, the results are often catastrophic. If the failure was not caused by an existing fire, the potential for a new fire resulting from the failure is extremely high. A power substation by its nature contains all of the right ingredients to generate the perfect fire storm. A typical substation transformer bank is comprised of three or more transformer tanks, each containing up to 45,000 gallons of extremely flammable mineral oil. The ignition of the hot oil can come from any number of sources during a failure including internal component failure, solid particles of insulation and conductor produced by arcing fault, or short circuit forces or electrical arcing inside the tank which then generates heat and pressure sufficient to rupture the tank.

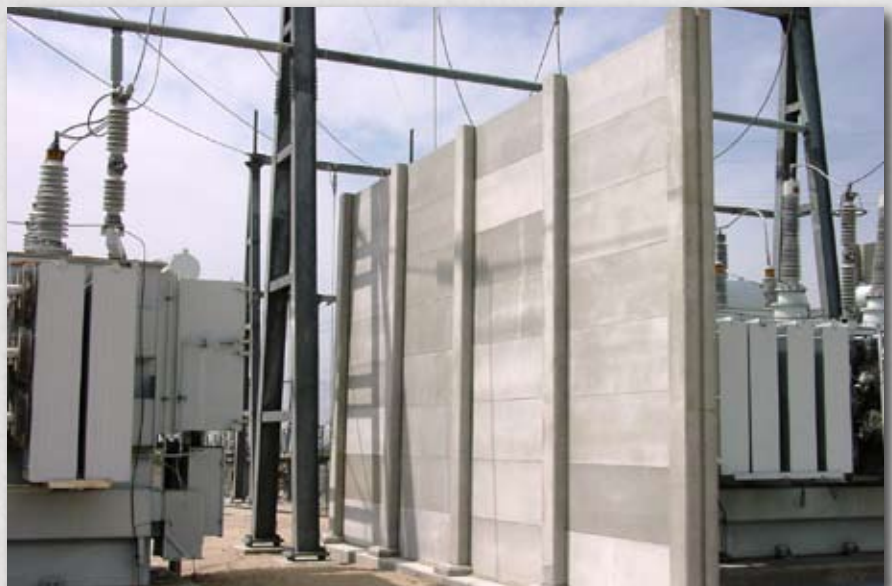
Installed Modular Refractory Concrete Firewall

Refractory Concrete refers to concrete made with refractory materials. Refractories are heat resistant materials that have the ability to withstand sudden temperature changes, prolonged high temperatures as well as load and abrasive forces. High alumina cements and fireclay refractory materials such as crushed fire brick are commonly used as aggregate in refractory concretes. Depending on the mix, refractory concretes can embody and exhibit exceptional reversible thermal expansion properties. When materials are heated they expand, and as they cool they contract. The reversible thermal expansion properties of a material determine the strength and stability it has as it cools through the various phase transformations. Refractory concrete is versatile in application and can either be cast in place or precast into relatively lightweight thermal panels and columns to create a stable, high performance fire containment wall

that retains considerable strength at temperatures of up to 1300C (2372 F). Refractories emit no volatile organic compounds or hazardous material when exposed to prolonged high temperatures, and have been used for centuries to handle molten metal in foundries and smelters. Refractory concretes are designed to meet the thermal and mechanical requirements over the service life of an electrical substation.

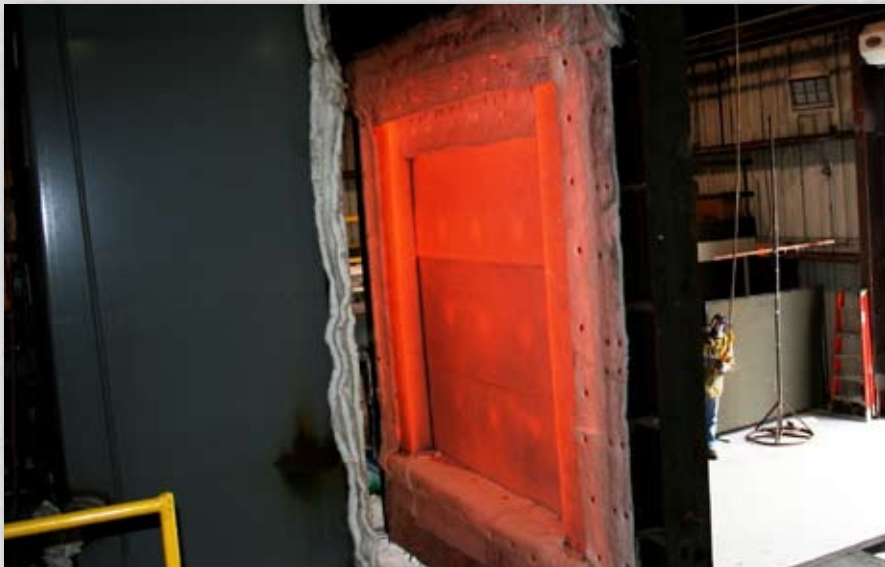
Refractory Concrete Firewall Test

Traditionally, fire walls are built from reinforced concrete and/or concrete blocks. Concrete made with common Portland cement is limited to temperatures up to about 650°C. When Portland cement-type concrete is exposed to temperatures above 700°C, the cement becomes dehydrated and loses its structural integrity, retaining only about 35% of its room temperature strength. While some firewalls incorporate steel panels or columns, steel has practically no strength left at 650°C and the failure process will accelerate as the temperatures increase. Typical concrete fire walls and firewalls made with steel components would fail under the actual conditions of a transformer oil fire because these materials do not perform as needed under those high temperatures. For a transformer fire containment wall to be successful in real world conditions it must be made of a material that enables it to withstand the extreme temperatures of an oil fire having a working temperature of between 960°C and 1200°C for a minimum of four-hours, followed immediately by a high-pressure water jet blast. One such material is refractory concrete.
